**Flood Control Project Maintenance
Levee Inspections**

Maintenance Issue Types Only, Levee Inspection Report By Mile - Fall 2016

Lower San Joaquin Levee District

Waterway	Bank	Unit Miles	Inspection Start/End	Inspector
Unit No. 01 San Joaquin River	Right	22.52	10/17/2016 10/20/2016	Richard Willoughby

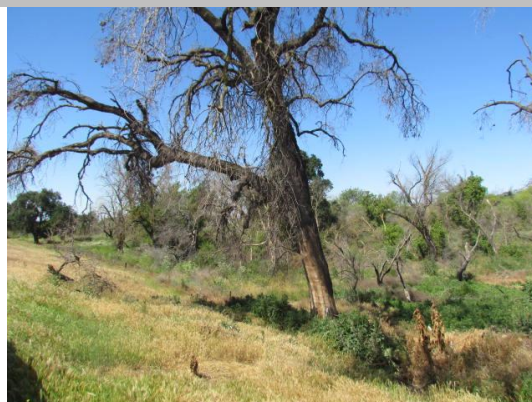
Photo 1 of 1 : FA_2016_NA0010_118_7_20161007_00005.jpg

LM Start	0.14	Rating **	U	Issue No.	7
LM End	0.14	Issue Type +	Ma	Location *	WS
Category	Earthen Levee			GPS Latitude/Longitude	
				Start	End
Item	Vegetation			37.347152 °	37.347152 °
				-120.960560 °	-120.960560 °
DWR ID	DWR_NA0010_01_s_2012_7				
Comment Code					
V7 : Trees / Woody Vegetation					
Inspector Comment					
Dead tree on waterward slope and toe.

Looking southwest at dead tree on landward slope and toe.

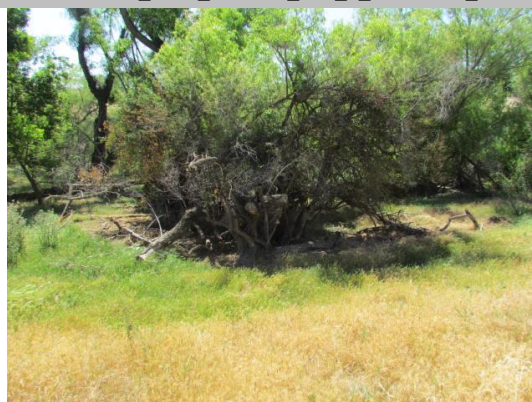
Photo 1 of 1 : FA_2016_NA0010_118_3_20161007_00002.jpg

LM Start	0.19	Rating **	M	Issue No.	3
LM End	0.19	Issue Type +	Ma	Location *	LS
Category	Earthen Levee			GPS Latitude/Longitude	
				Start	End
Item	Trim / Thin Trees			37.346576 °	37.346576 °
				-120.961061 °	-120.961061 °
DWR ID	DWR_NA0010_01_s_2016_3				
Comment Code					
T2 : Thin trees to allow visibility of the ground and room to flood fight.					
Inspector Comment					
Dead tree (limbs & branches) blocking landward right of way/ berm.

Looking east at brush and tree limbs blocking landward toe.

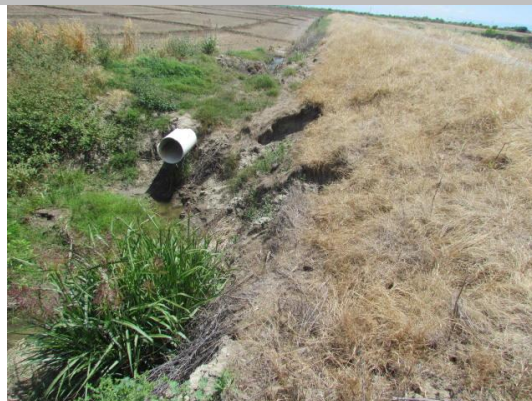
Photo 1 of 3 : FA_2016_NA0010_118_1179_20161007_00022.jpg

Looking south at erosion on landward slope and toe.

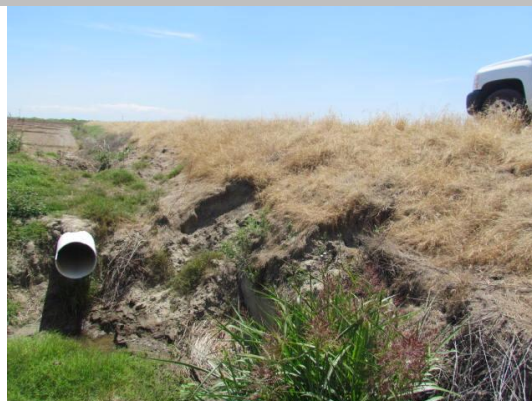
Photo 2 of 3 : FA_2016_NA0010_118_1179_20161007_00023.jpg

Looking southwest at erosion on landward slope and toe.

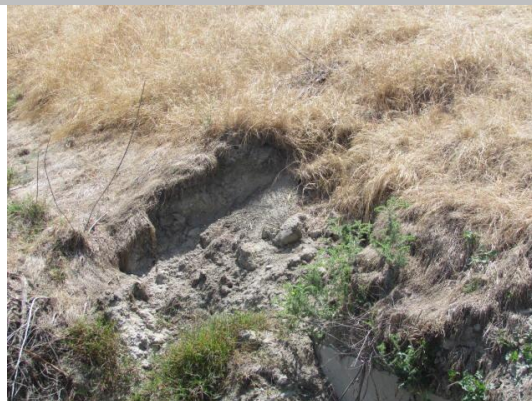
Photo 3 of 3 : FA_2016_NA0010_118_1179_20161007_00024.jpg

Looking west at erosion on landward slope and toe.

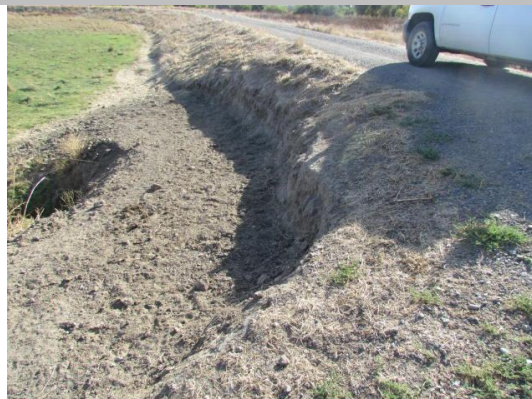
Photo 1 of 1 : FA_2016_NA0010_118_9_20161007_00006.jpg

LM Start	4.69	Rating **	U	Issue No.	9
LM End	4.69	Issue Type +	Ma	Location *	LS
Category	Earthen Levee			GPS Latitude/Longitude	
				Start	End
Item	Animal Control			37.302398 °	37.302398 °
				-120.920920 °	-120.920920 °
DWR ID	DWR_NA0010_01_s_2013_9				
Comment Code					
A2 : Repair the levee slope damaged by livestock and prevent large animal access.					
Inspector Comment					
Levee landward toe damaged by livestock.

Looking at landward slope damaged by livestock.

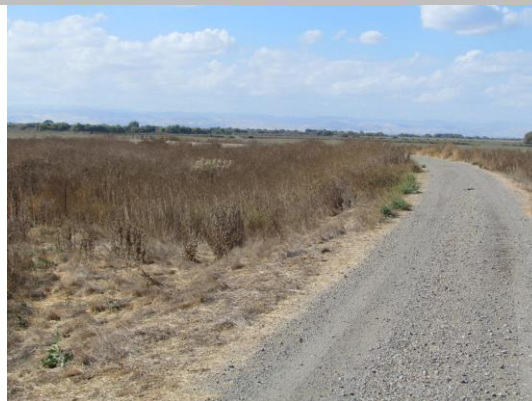
Photo 1 of 2 : FA_2016_NA0010_118_93_20161024_00233.jpg

Looking at dense veg on waterward slope. (Fall 2016)

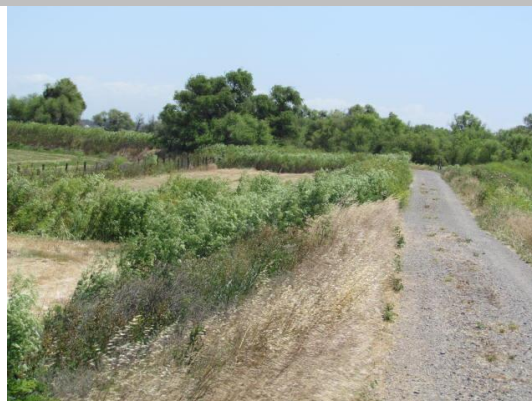
Photo 2 of 2 : FA_2016_NA0010_118_93_20161007_00018.jpg

Looking at dense veg on waterward slope. (Spring 2016)

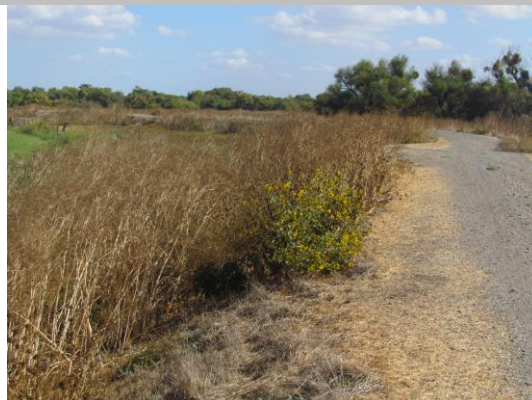
Photo 1 of 2 : FA_2016_NA0010_118_92_20161024_00234.jpg

LM Start	5.87	Rating **	U	Issue No.	92
LM End	6.86	Issue Type +	Ma	Location *	LS
Category	Earthen Levee			GPS Latitude/Longitude	
				Start	End
Item	Vegetation			37.303555 °	37.302118 °
				-120.904541 °	-120.887957 °
DWR ID	DWR_NA0010_01_f_2015_92				
Comment Code					
V2 : Remove the wild growth other than native grasses from the levee slopes.					
Inspector Comment

Looking south at dense veg on landward slope. (Fall 2016)

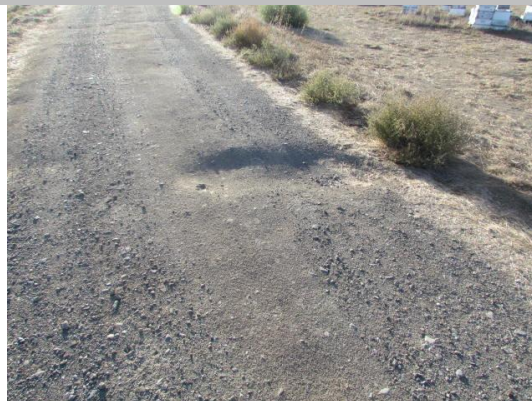
Photo 1 of 3 : FA_2016_NA0010_118_14_20161007_00010.jpg

LM Start	9.57	Rating **	M	Issue No.	14
LM End	9.57	Issue Type +	Ma	Location *	CR
Category	Earthen Levee			GPS Latitude/Longitude	
				Start	End
Item	Crown Surface / Depressions / Rutting			37.295517 °	37.295517 °
				-120.841452 °	-120.841452 °
DWR ID	DWR_NA0010_01_s_2015_14				
Comment Code					
C2 : Repair depressions or ruts in the crown or slope.					
Inspector Comment					
Depression greater than 3" deep by 18" wide by 18" long on levee crown

Looking at depression on levee crown. (Fall 2015)

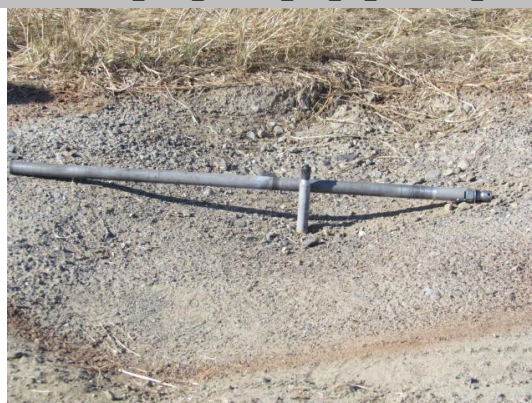
Photo 2 of 3 : FA_2016_NA0010_118_14_20161007_00011.jpg

Looking west at depression greater than three inches on levee crown.

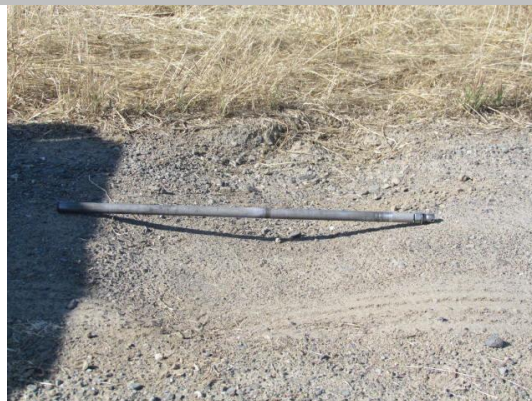
Photo 3 of 3 : FA_2016_NA0010_118_14_20161007_00012.jpg

Looking west at depression on levee crown.

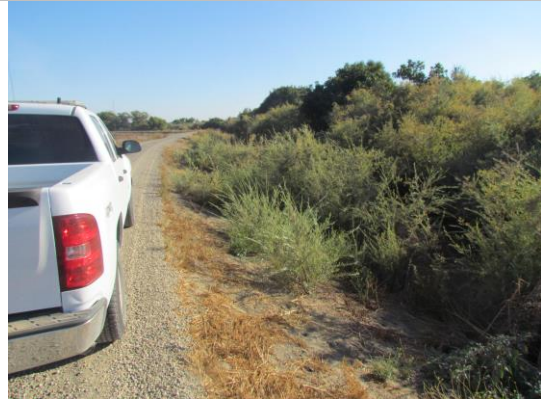
Photo 1 of 1 : FA_2016_NA0010_118_8_20161024_00238.jpg

Looking downstream at dense veg on waterward slope.

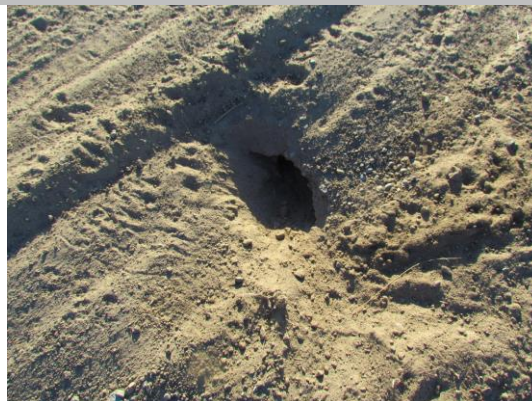
Photo 2 of 2 : FA_2016_NA0010_119_22_20161024_00071.jpg

Looking at close-up of rodent hole on levee crown.

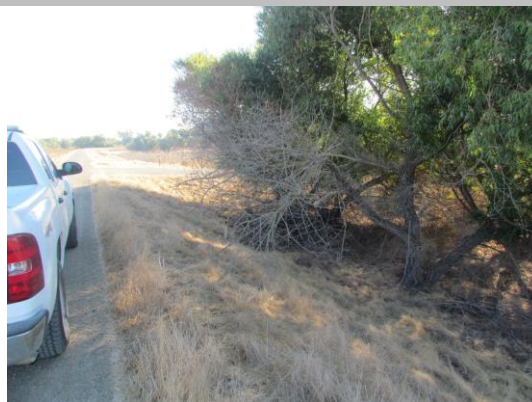
Photo 1 of 1 : FA_2016_NA0010_120_17_20161024_00005.jpg

Looking at dead tree limb on landward slope.

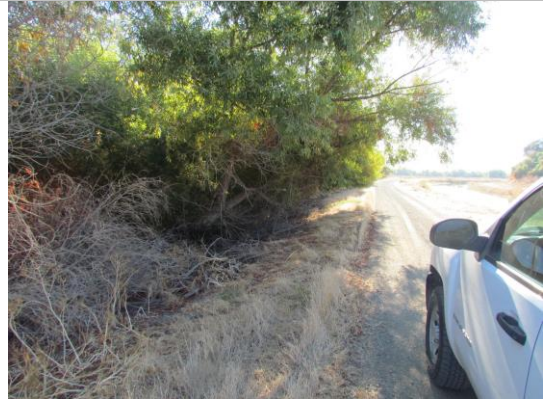
Photo 1 of 1 : FA_2016_NA0010_120_167_20161024_00009.jpg

Looking south at untrimmed trees on waterward slope.

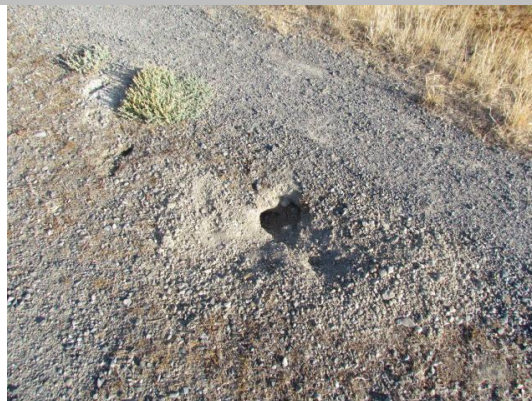
Photo 1 of 1 : FA_2016_NA0010_123_80_20161007_00011.jpg

Looking at typical view of rodent holes within this section on landward slope.

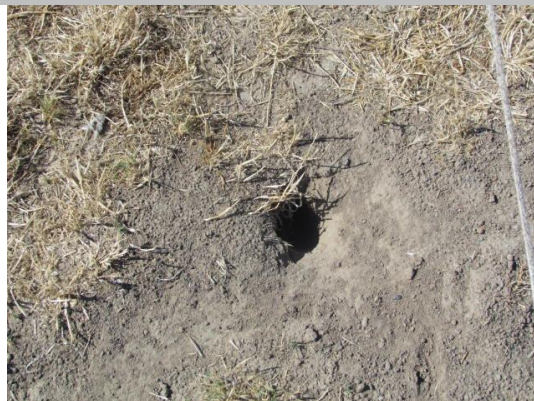
Photo 1 of 1 : FA_2016_NA0010_123_6_20161007_00003.jpg

Looking at typical view of rodent holes on waterward slope.

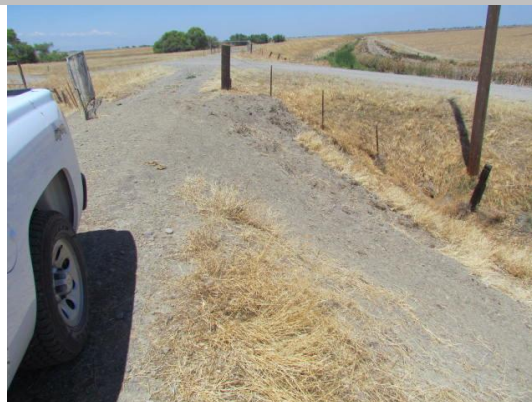
Photo 1 of 2 : FA_2016_NA0010_123_1309_20161007_00015.jpg

LM Start	6.59	Rating **	M	Issue No.	1309
LM End	6.59	Issue Type +	Ma	Location *	LS
Category	Earthen Levee			GPS Latitude/Longitude	
				Start	End
Item	Slope Stability			37.229682 °	37.229682 °
				-120.726305 °	-120.726305 °
DWR ID	DWR_NA0010_05_s_2015_1309				
Comment Code					
S2 : Repair the levee slope damaged by foot traffic and prevent access where possible.					
Inspector Comment					
Landward slope damage caused by animal foot traffic.

Looking north at damaged landward slope.

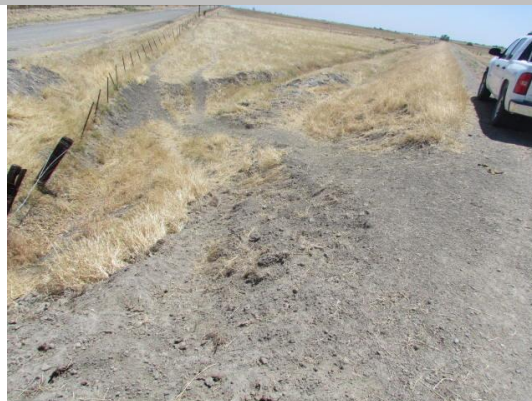
Photo 2 of 2 : FA_2016_NA0010_123_1309_20161007_00016.jpg

LM Start	6.59	Rating **	M	Issue No.	1309 (cont)	
LM End	6.59	Issue Type +	Ma	Location *	LS	
Category	Earthen Levee			GPS Latitude/Longitude		
				Start		End
Item	Slope Stability			37.229682 °		37.229682 °
				-120.726305 °		-120.726305 °
DWR ID	DWR_NA0010_05_s _ 2015_1309					
Comment Code						
S2 : Repair the levee slope damaged by foot traffic and prevent access where possible.						
Inspector Comment						
Landward slope damage caused by animal foot traffic.

Looking east at damaged landward slope.

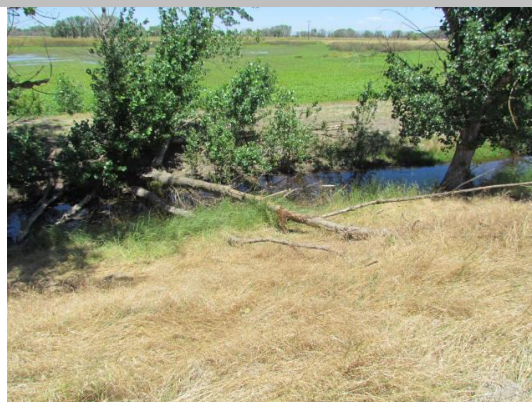
Photo 1 of 1 : FA_2016_NA0010_123_2_20161007_00002.jpg

Looking west at down tree at landward toe.

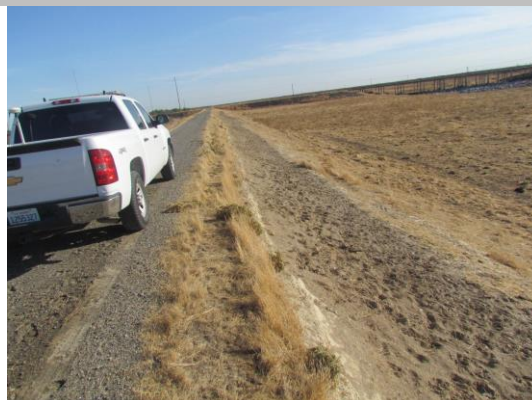
Photo 1 of 2 : FA_2016_NA0010_123_171_20161024_00208.jpg

LM Start	29.68	Rating **	M	Issue No.	171
LM End	29.80	Issue Type +	Ma	Location *	WS
Category	Earthen Levee			GPS Latitude/Longitude	
				Start	End
Item	Erosion / Bank Caving			37.020272 °	37.018712 °
				-120.433737 °	-120.432682 °
DWR ID	DWR_NA0010_05_s_2014_171				
Comment Code					
E1 : Note and monitor erosion site.					
Inspector Comment					
Waterside erosion caused by livestock.

Looking south at animal erosion on waterward slope.

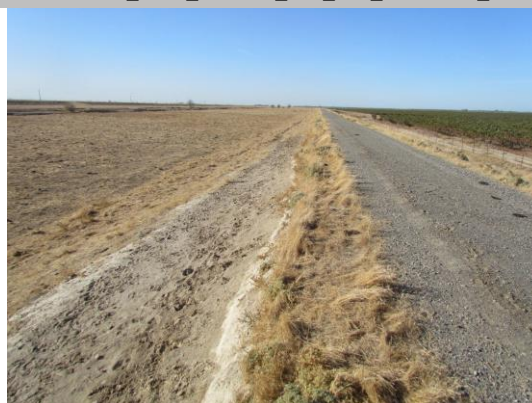
Photo 2 of 2 : FA_2016_NA0010_123_171_20161024_00209.jpg

Looking north at animal erosion on waterward slope.

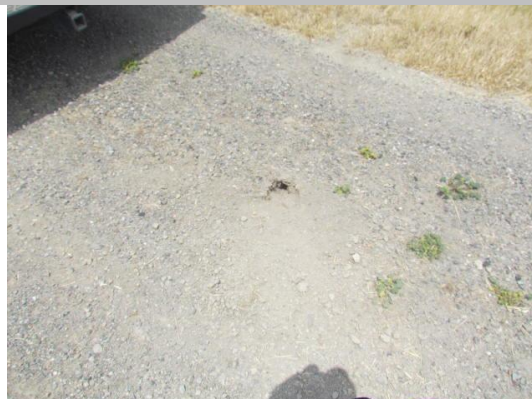
Photo 1 of 1 : FA_2016_NA0010_124_1212_20161007_00040.jpg

LM Start	14.94	Rating **	M	Issue No.	1212
LM End	14.94	Issue Type +	Ma	Location *	CR
Category	Earthen Levee			GPS Latitude/Longitude	
				Start	End
Item	Animal Control			37.162287 °	37.162287 °
				-120.628791 °	-120.628791 °
DWR ID	DWR_NA0010_06_s_2015_1212				
Comment Code					
A3 : No rodents visible, but rodent burrows visible; need to backfill and compact or grout burrows.					
Inspector Comment					
Several rodent holes noted on levee crown and landside and waterside slopes.

Looking at rodent hole on levee crown.

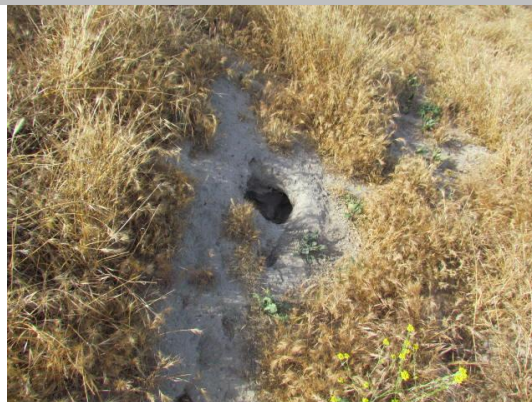
Photo 1 of 5 : FA_2016_NA0010_124_1211_20161007_00035.jpg

LM Start	19.14	Rating **	U	Issue No.	1211
LM End	19.14	Issue Type +	Ma	Location *	WS
Category	Earthen Levee			GPS Latitude/Longitude	
				Start	End
Item	Animal Control			37.114793 °	37.114793 °
				-120.587582 °	-120.587582 °
DWR ID	DWR_NA0010_06_s_2015_1211				
Comment Code					
A1 : Exterminate rodents and backfill and compact or grout burrows.					
Inspector Comment					
Several large rodent holes with more than 2 cubic feet of material was noted on waterward slope

Looking at rodent hole on waterward slope. Spring 2016

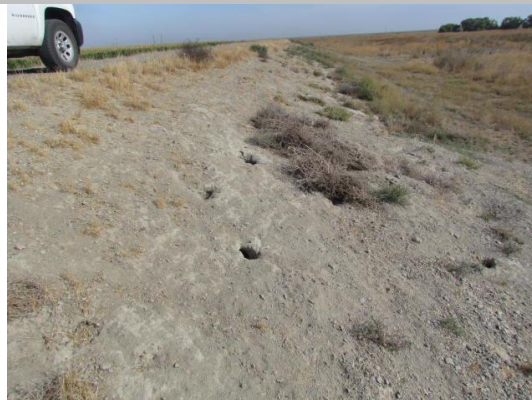
Photo 2 of 5 : FA_2016_NA0010_124_1211_20161007_00036.jpg

Looking at several rodent holes on waterward slope. (Fall 2015)

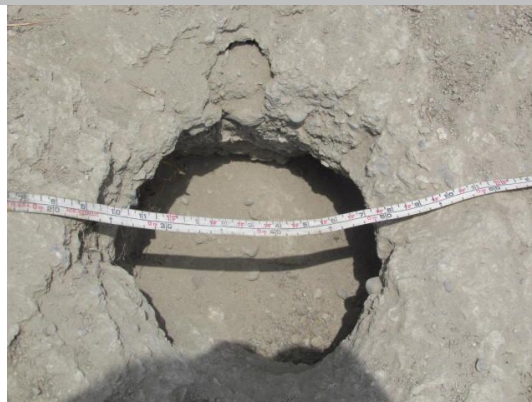
Photo 3 of 5 : FA_2016_NA0010_124_1211_20161007_00037.jpg

Looking at close-up view of large rodent hole on waterward slope.
(Spring 2015)

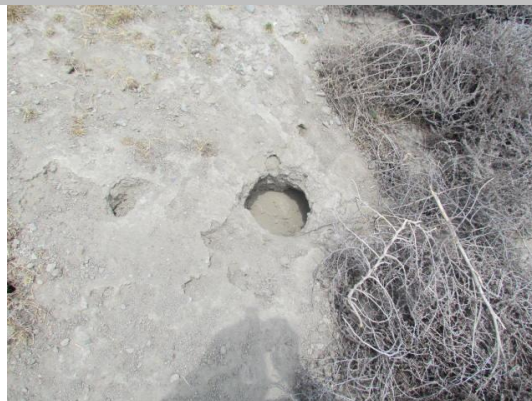
Photo 4 of 5 : FA_2016_NA0010_124_1211_20161007_00038.jpg

LM Start	19.14	Rating **	U	Issue No.	1211 (cont)	
LM End	19.14	Issue Type +	Ma	Location *	WS	
Category	Earthen Levee			GPS Latitude/Longitude		
				Start		End
Item	Animal Control			37.114793 °		37.114793 °
				-120.587582 °		-120.587582 °
DWR ID	DWR_NA0010_06_s_2015_1211					
Comment Code						
A1 : Exterminate rodents and backfill and compact or grout burrows.						
Inspector Comment						
Several large rodent holes with more than 2 cubic feet of material was noted on waterward slope

Looking at large rodent hole on waterward slope. Spring 2015

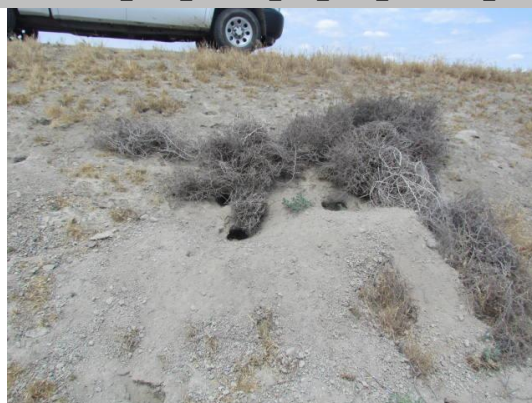
Photo 5 of 5 : FA_2016_NA0010_124_1211_20161007_00039.jpg

Looking west at several rodent holes on waterward slope. Spring 2015

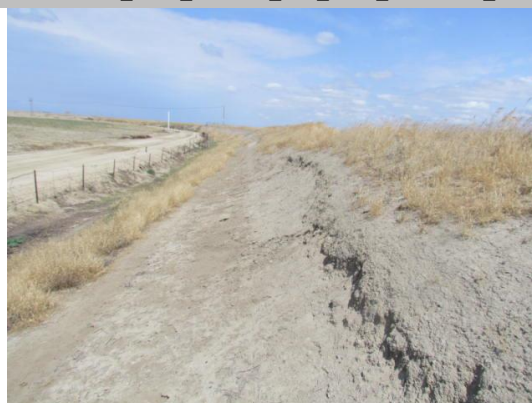
Photo 1 of 2 : FA_2016_NA0010_124_1209_20161007_00033.jpg

LM Start	20.79	Rating **	U	Issue No.	1209
LM End	20.88	Issue Type +	Ma	Location *	LS
Category	Earthen Levee			GPS Latitude/Longitude	
				Start	End
Item	Erosion / Bank Caving			37.113107 °	37.112176 °
				-120.563782 °	-120.562516 °
DWR ID	DWR_NA0010_06_s_2015_1209				
Comment Code					
E1 : Note and monitor erosion site.					
Inspector Comment					
Erosion on landward slope greater than 3 inches. Erosion caused by livestock.

Looking north at livestock erosion on landward slope.

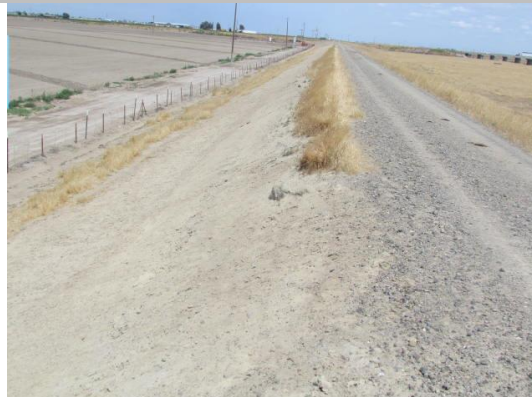
Photo 1 of 3 : FA_2016_NA0010_124_5_20161007_00013.jpg

Looking north at livestock erosion on landward slope. (Spring 2015)

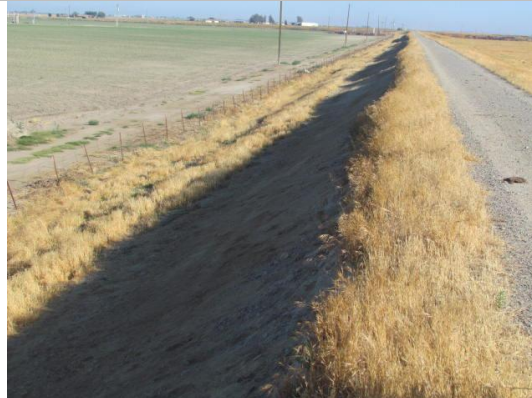
Photo 2 of 3 : FA_2016_NA0010_124_5_20161007_00014.jpg

Looking north at livestock erosion on landward slope. (Spring 2014)

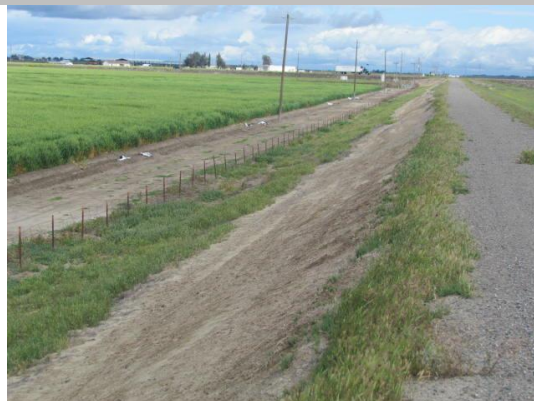
Photo 3 of 3 : FA_2016_NA0010_124_5_20161007_00015.jpg

Looking north at livestock erosion on landside slope. (Fall 2014)

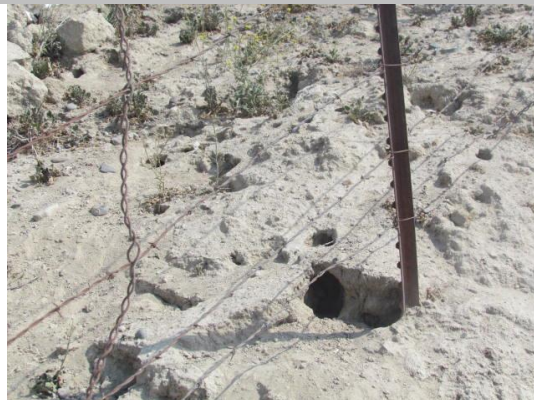
Photo 1 of 1 : FA_2016_NA0010_124_1208_20161007_00032.jpg

Rodent holes on landward slope.

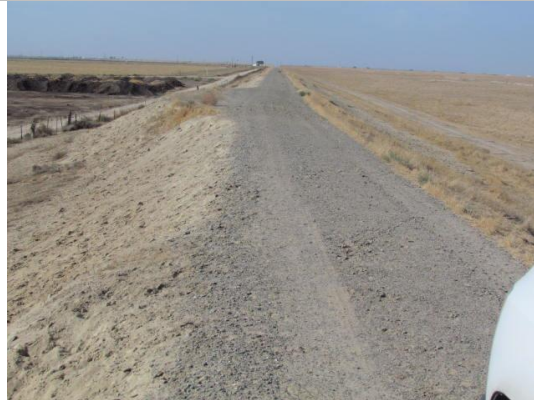
Photo 1 of 4 : FA_2016_NA0010_124_3_20161007_00009.jpg

Looking north at livestock erosion on landward slope. Fall 2015

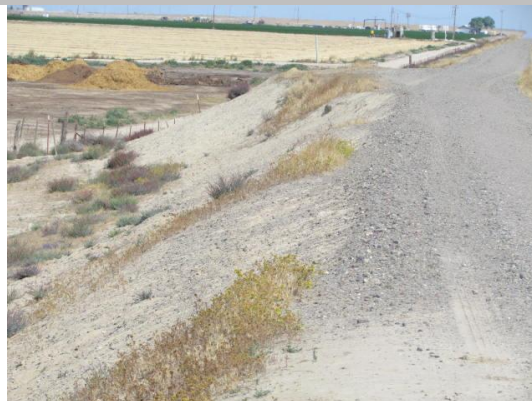
Photo 2 of 4 : FA_2016_NA0010_124_3_20161007_00010.jpg

Looking north at livestock erosion on landward shoulder and slope.(Spring 2015)

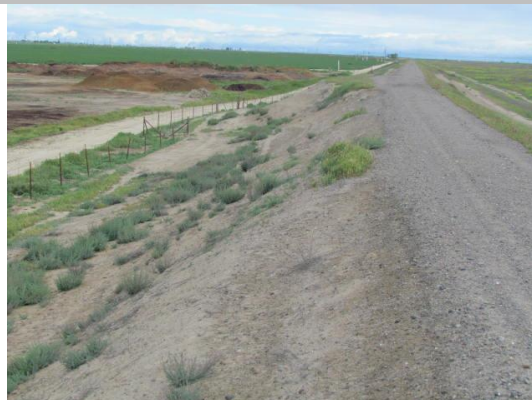
Photo 3 of 4 : FA_2016_NA0010_124_3_20161007_00011.jpg

Looking north at livestock erosion on landside shoulder and slope. (Fall 2014)

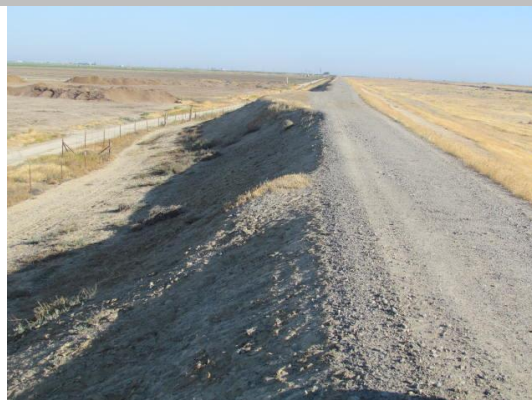
Photo 4 of 4 : FA_2016_NA0010_124_3_20161007_00012.jpg

Looking north at livestock erosion on landward slope. (Spring 2013)

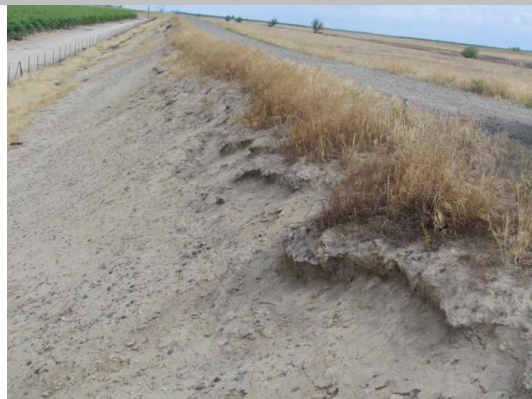
Photo 1 of 2 : FA_2016_NA0010_124_1207_20161007_00030.jpg

Looking northeast at livestock erosion on landward slope.

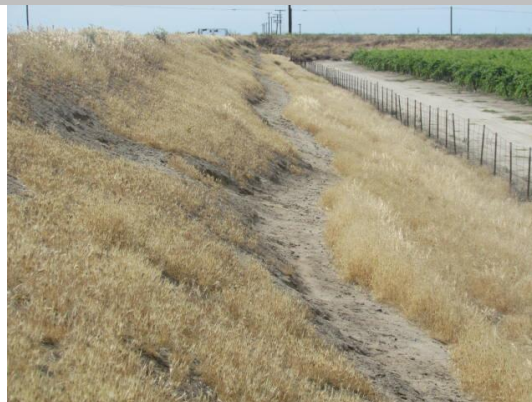
Photo 2 of 2 : FA_2016_NA0010_124_1207_20161007_00031.jpg

Looking south at livestock erosion on landward slope.

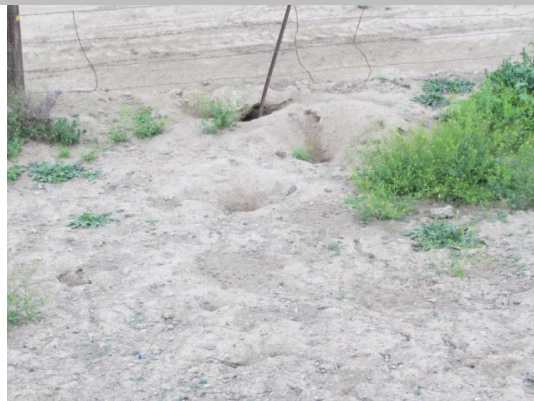
Photo 1 of 2 : FA_2016_NA0010_124_2_20161007_00007.jpg

Looking west at rodent holes on landside slope and toe near fence line.

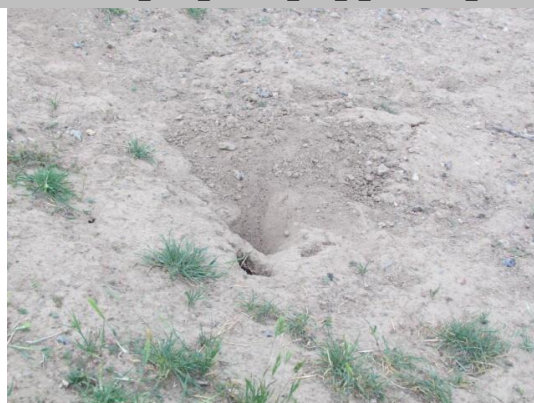
Photo 2 of 2 : FA_2016_NA0010_124_2_20161007_00008.jpg

Looking at typical rodent hole on landside slope.

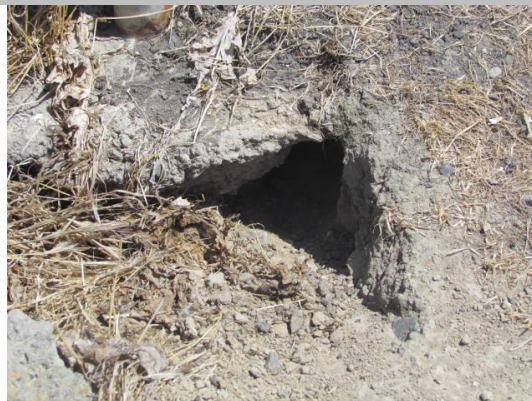
Photo 2 of 2 : FA_2016_NA0010_125_12_20161007_00004.jpg

Looking at rodent activity next to fence post

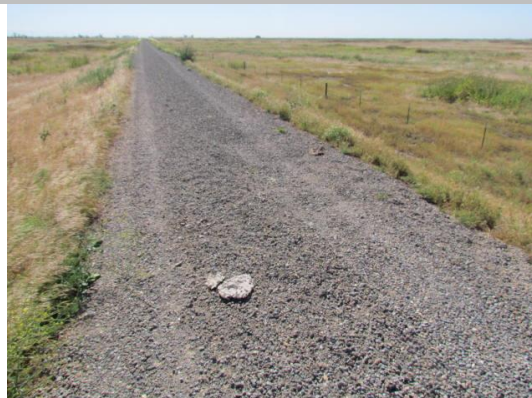
Photo 1 of 1 : FA_2016_NA0010_126_5_20161007_00002.jpg

Looking west at depression on toward landward shoulder.

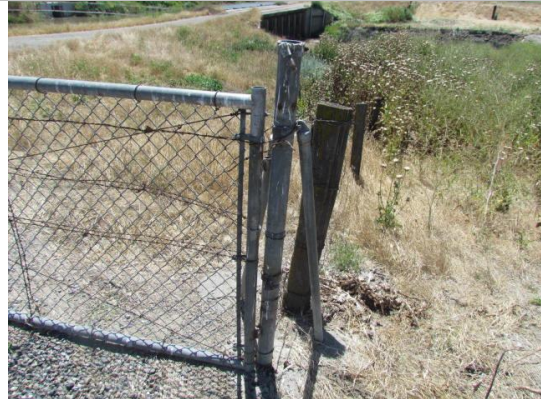
Photo 1 of 1 : FA_2016_NA0010_127_5_20161007_00001.jpg

Looking at missing hinges on fence post.

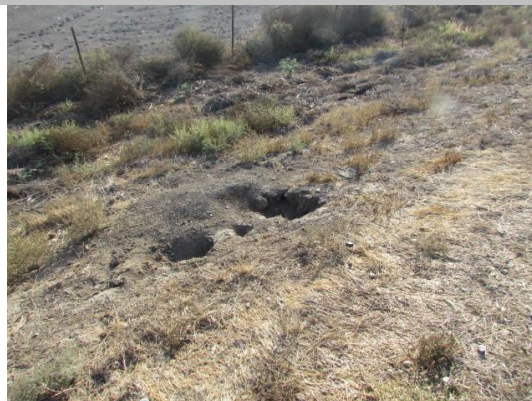
Photo 2 of 2 : FA_2016_NA0010_134_2_20161007_00002.jpg

Looking southwest at several rodent holes on landward slope.

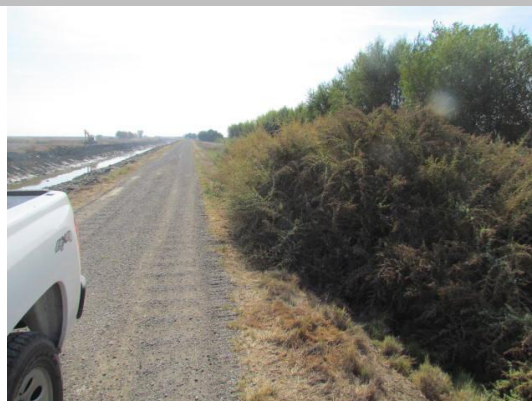
Photo 2 of 2 : FA_2016_NA0010_138_21_20161007_00009.jpg

Looking south at dense vegetation on landward slope. Spring 2015

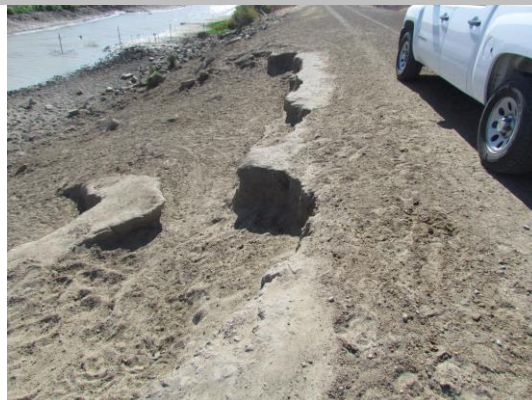
Photo 1 of 1 : FA_2016_NA0010_138_13_20161024_00024.jpg

Looking at animal erosion on waterwater slope.

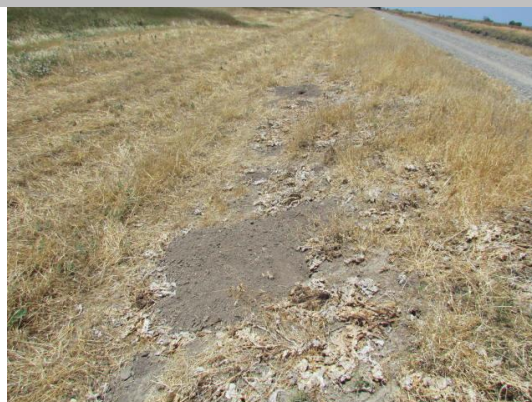
Photo 1 of 1 : FA_2016_NA0010_138_15_20161007_00007.jpg

Looking at several rodent holes on landward slope.

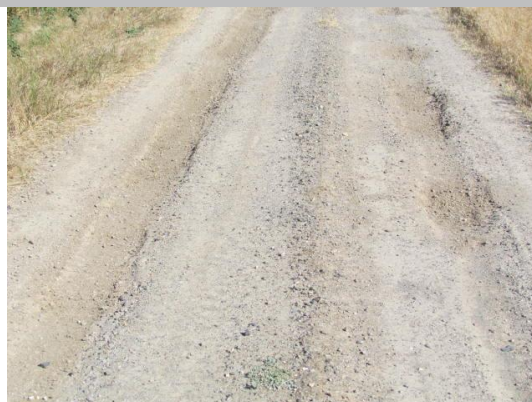
Photo 1 of 1 : FA_2016_NA0010_138_10_20161007_00005.jpg

Looking west at typical rutting on levee crown.

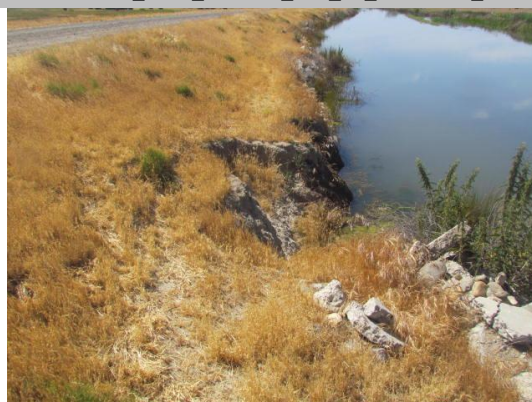
Photo 1 of 1 : FA_2016_NA0010_138_12_20161007_00006.jpg

Looking northwest at slope damage cause by animal traffic on waterside slope.

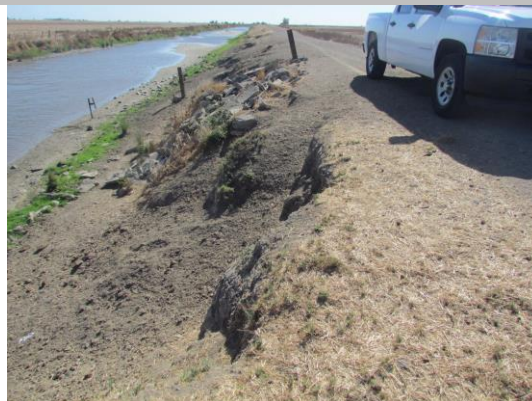
Photo 1 of 2 : FA_2016_NA0010_138_8_20161024_00026.jpg

Looking downstream at animal erosion on waterward slope.

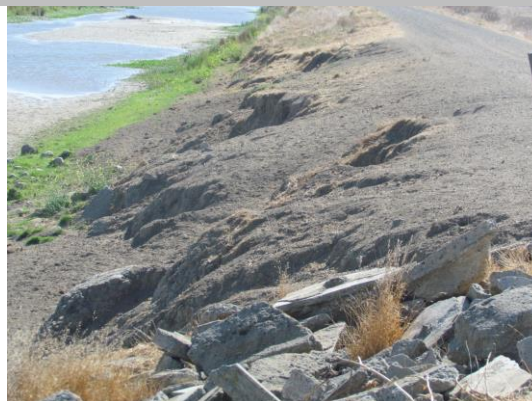
Photo 2 of 2 : FA_2016_NA0010_138_8_20161024_00027.jpg

Looking downstream at animal erosion on waterward slope.

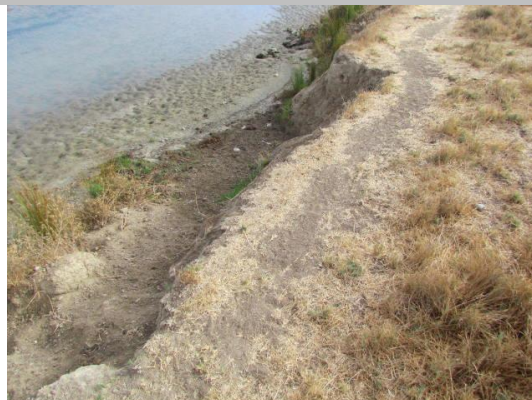
Photo 1 of 2 : FA_2016_NA0010_138_4_20161007_00001.jpg

Looking southeast at livestock erosion on waterward toe.

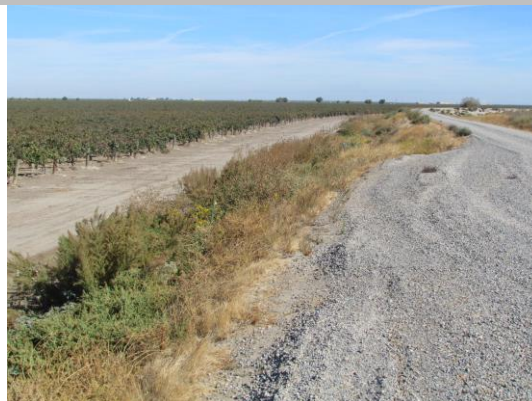
Photo 1 of 1 : FA_2016_NA0010_139_20_20161024_00051.jpg

Looking at typical view of dense veg on landward slope.

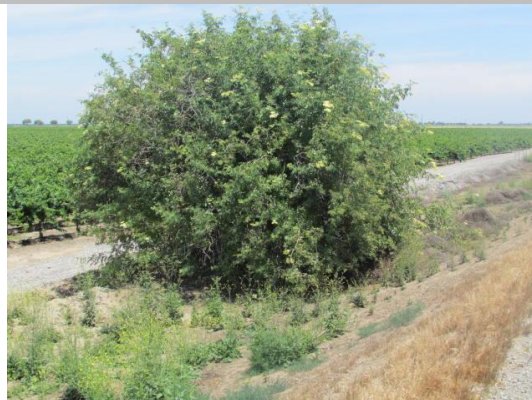
Photo 1 of 1 : FA_2016_NA0010_139_6_20161007_00007.jpg

Looking at elderberry on landward toe.

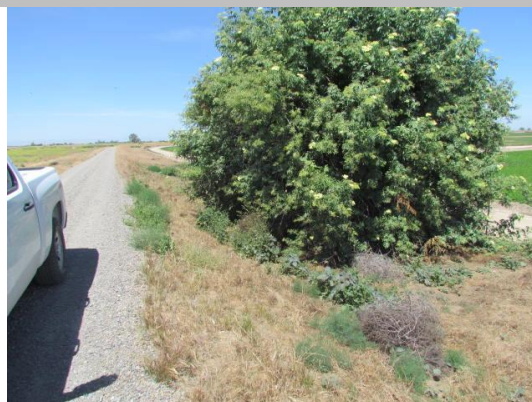
Photo 1 of 3 : FA_2016_NA0010_139_15_20161007_00014.jpg

Looking west at elderberry at landward toe. (Spring 2016)

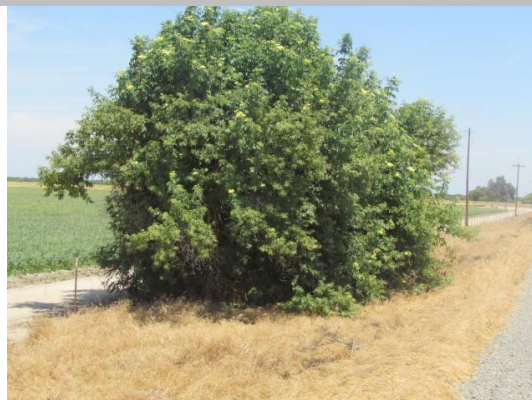
Photo 2 of 3 : FA_2016_NA0010_139_15_20161007_00015.jpg

Looking east at elderberry at landward toe. (Spring 2015)

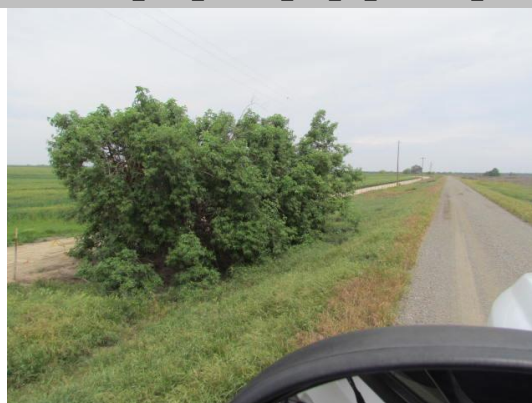
Photo 3 of 3 : FA_2016_NA0010_139_15_20161007_00016.jpg

Looking east at elderberry on landside toe and berm. (Fall 2014)

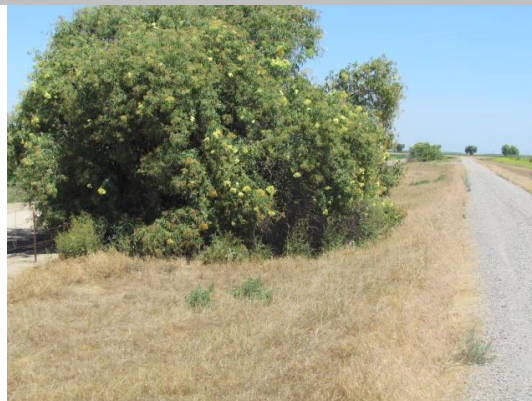
Photo 1 of 4 : FA_2016_NA0010_139_3_20161007_00002.jpg

Looking North at elderberry on landward toe and berm. (Spring 2016)

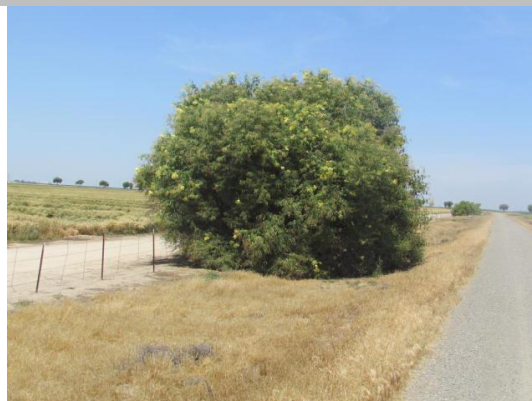
Photo 2 of 4 : FA_2016_NA0010_139_3_20161007_00003.jpg

Looking north at elderberry on landward toe and berm. (Spring 2015)

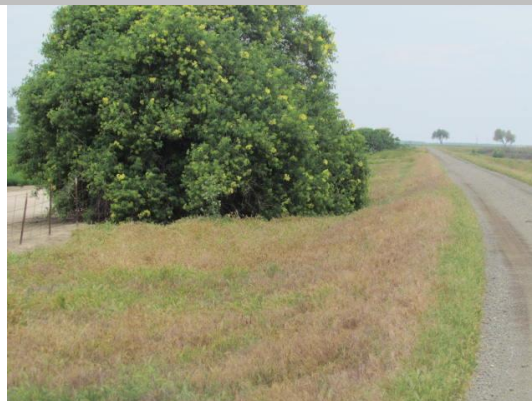
Photo 3 of 4 : FA_2016_NA0010_139_3_20161007_00004.jpg

Looking north at elderberry on landside toe and berm. (Fall 2014)

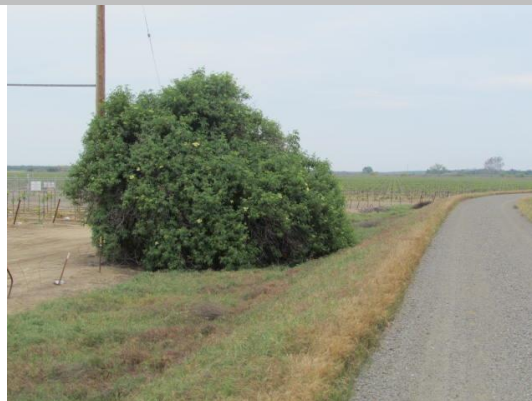
Photo 2 of 3 : FA_2016_NA0010_139_10_20161007_00010.jpg

Looking east at elderberry on landside toe and berm. (Spring 2015)

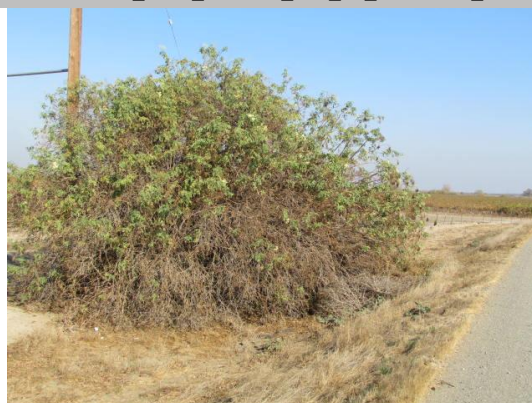
Photo 3 of 3 : FA_2016_NA0010_139_10_20161007_00011.jpg

Looking east at elderberry bush on landward toe. (Fall 2013)

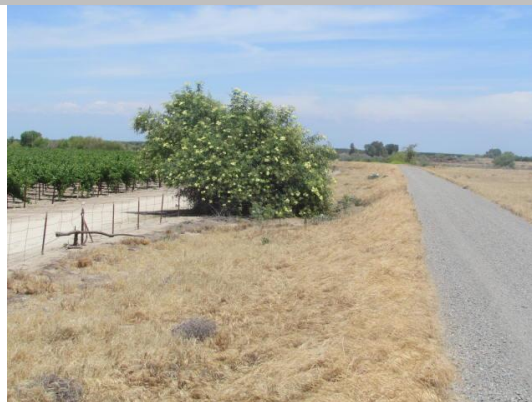
Photo 1 of 2 : FA_2016_NA0010_139_11_20161007_00012.jpg

Looking northeast at elderberry on landward toe and berm. (Spring 2015)

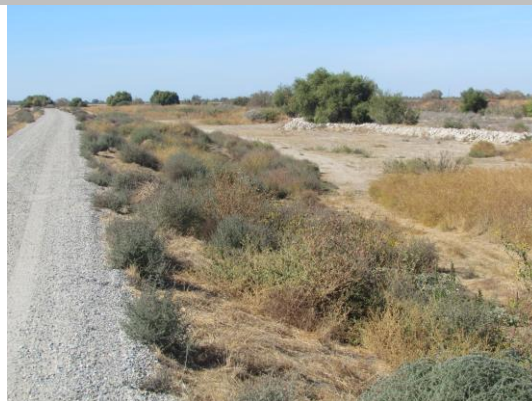
Photo 1 of 1 : FA_2016_NA0010_140_12_20161024_00030.jpg

Looking at typical view of dense veg on waterward slope.

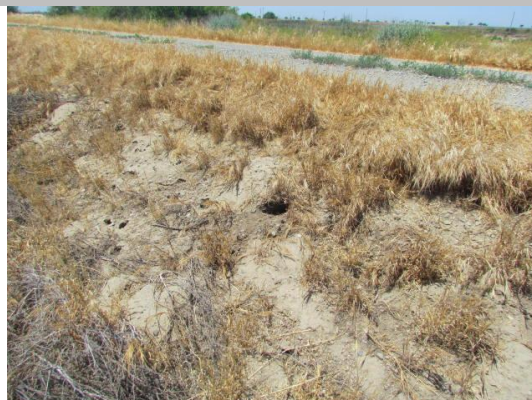
Photo 1 of 1 : FA_2016_NA0010_140_7_20161007_00004.jpg

Looking east at one of several rodent holes on landward slope.

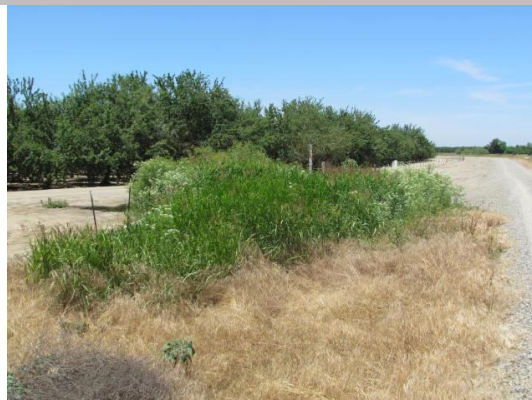
Photo 1 of 1 : FA_2016_NA0010_140_15_20161007_00005.jpg

Looking northwest at dense veg on landward slope and toe.

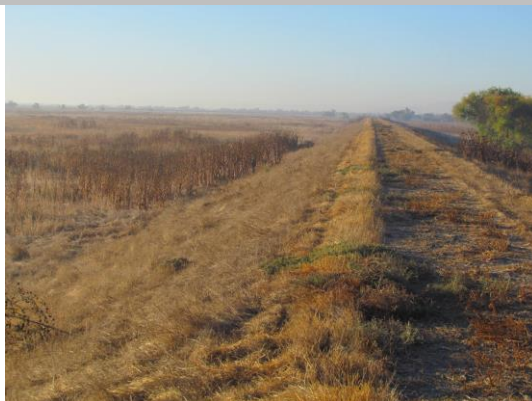
Photo 1 of 2 : FA_2016_NA0010_141_7_20161024_00022.jpg

Looking at typical view of dense veg on landward slope. (Fall 2016)

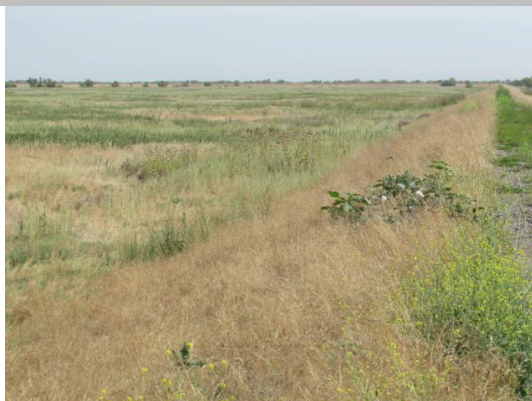
Photo 2 of 2 : FA_2016_NA0010_141_7_20161007_00001.jpg

Looking at typical view of landward slope. (Spring 2016)
